Manhole Inspection Summary

Manhole # S23C1_022MH

Insp Date: **7/7/08 8:30 AM**

Location Address: **2420 Puget St** Cross Street: **Holland Ferry Rd**

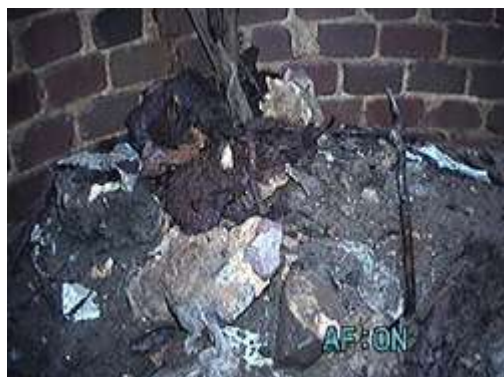
Defect 1

Bench ☒ Exists Material: **Brick** ☐ Parged
Condition: ☐ Sound ☐ Cracked ☐ Root Intrusion ☐ Deteriorated ☐ Leaks ☒ **Debris**

debris on bench

Manhole Type: **Inline** Location: **Roadway** Ground Conditions: **Dry**
☐ Prev. Rehab Weather: **Dry** Subject To Ponding: **None**
Comments **Sticks stuffed behind rungs require flatbed crew while other debris could be addressed by vactor.**

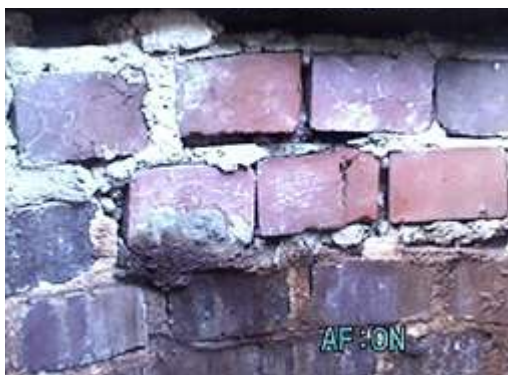
Defect 3

Chimney / Frame Adjustment ☒ Exists Material: **Brick** ☐ Parged Height: **5** (in.)
Condition: ☐ Sound ☐ Cracked ☐ Root Intrusion ☐ Loose Brick ☒ **Deteriorated**
Infiltration: ☐ None ☒ **Joint** ☐ Cracks ☒ **Mortar** ☐ Roots ☐ Wall

chimney deteriorated, infiltration at frame joint and mortar

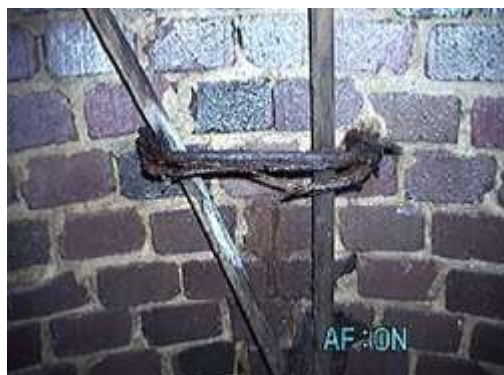
Defect 2

Steps Count: **4** Missing: **0** ☒ **Corroded**

steps corroded

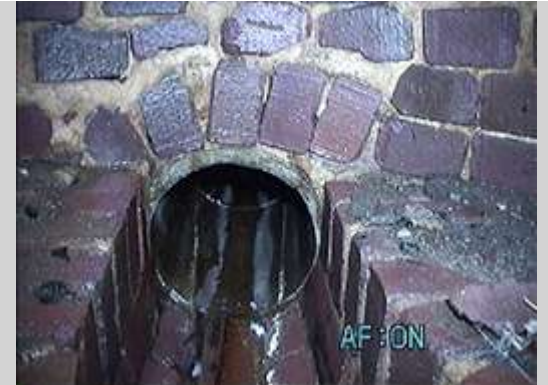
12 O'Clock Outflow

8 in. Circular Gravity Sewer
Pipe Out @ 12 O'Clock

Infiltration: **None** Pipe Seal Cond: **Sound**

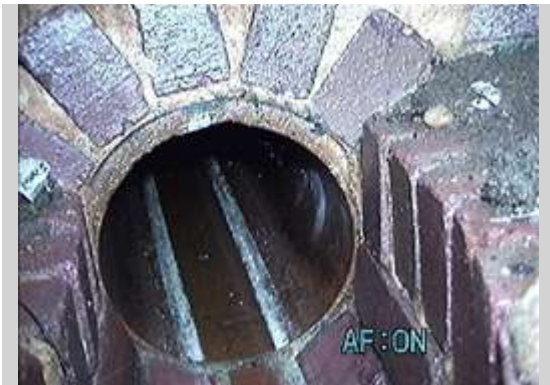
3 O'Clock Inflow

8 in. Circular Gravity Sewer
Pipe In @ 3 O'Clock

Infiltration: **None** Pipe Seal Cond: **Sound**
